**Whittle Roundabout, Lutterworth, Leicestershire
Redecoration of Replica Aeroplane**

Following my general inspection of the above on 3 August 2016, I report below under a series of headings:

WHITTLE ROUNDABOUT, LUTTERWORTH
GENERAL PHOTOGRAPHS : 3 AUGUST 2016

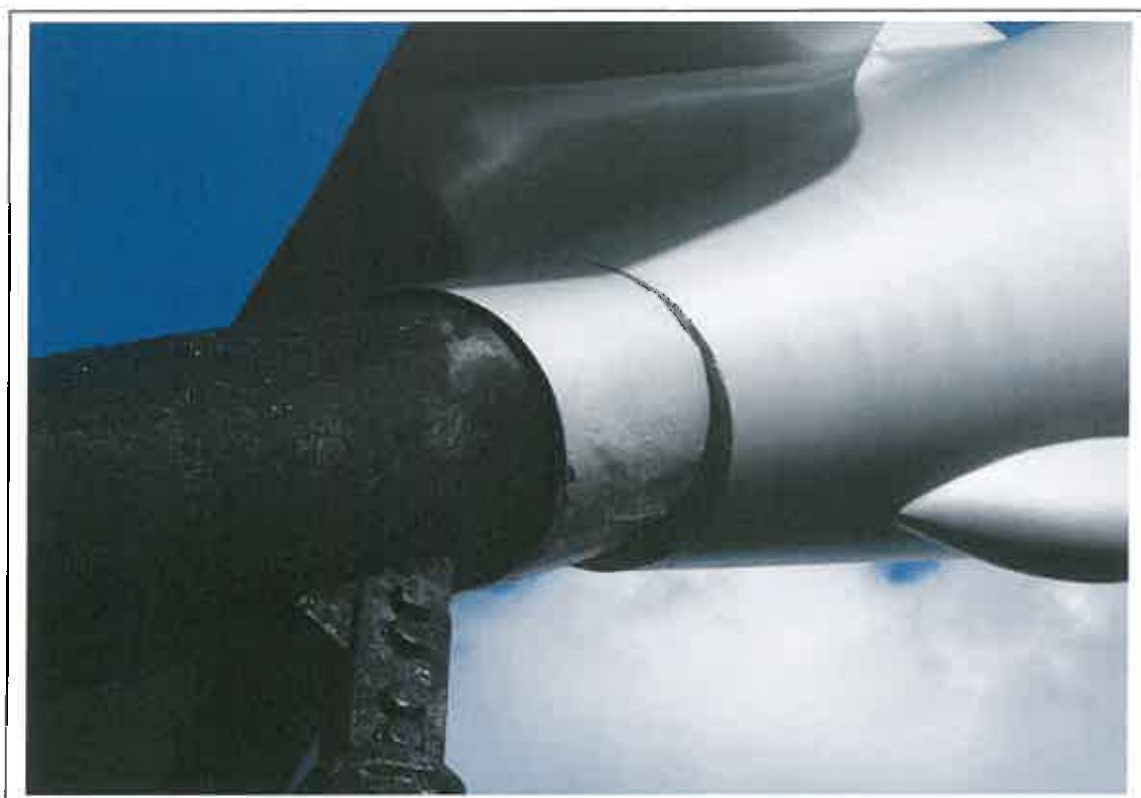
17. General view

A selection of photographs taken at the time of my recent inspection is attached for your file. You will note from photograph no. 17 that the tailpipe of the aeroplane, at its point of connection with the main support post, is generally uneven beneath the surface of the new paintwork. It is entirely possible that the top coat of material used to construct the aeroplane is delaminating in this location, albeit the new paint system fully encapsulates this and so I would not anticipate any associated issues arising in the short term, unless the new paint system begins to break down in this location.
