Hursley Park, Welham Road, Great Bowden, Leicestershire

Site Inspection and Report

22.1652.R1

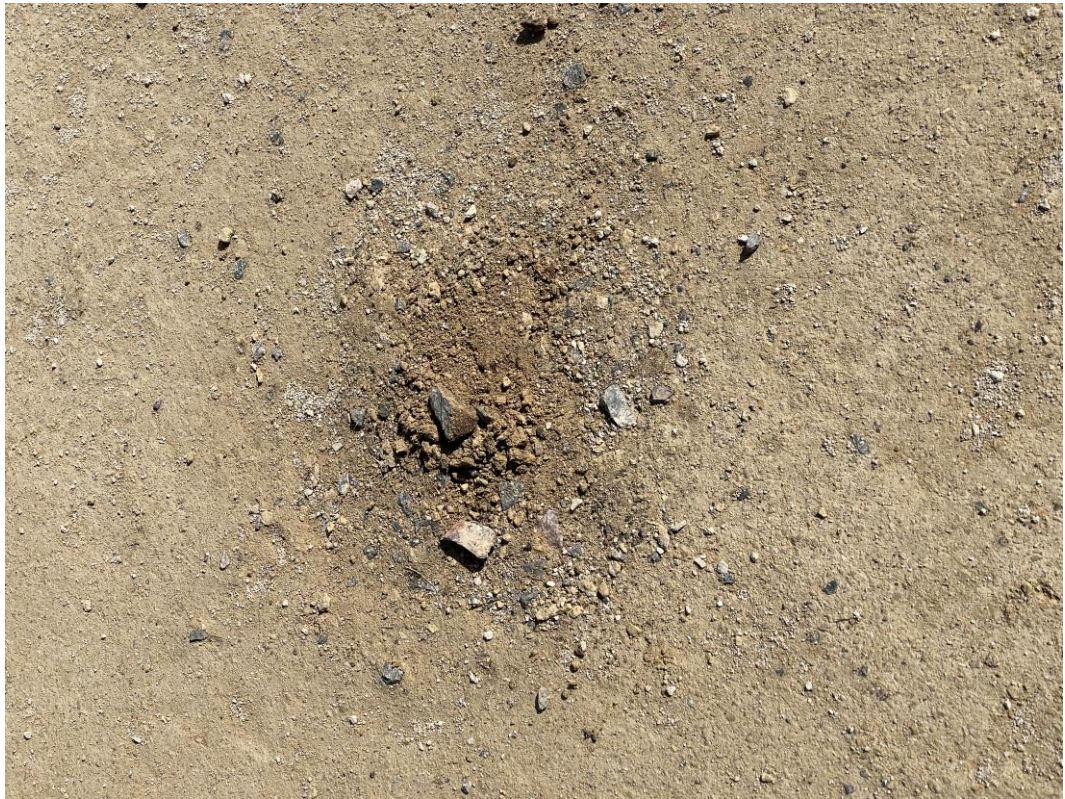
It was apparent in many places that the rolled gravel surface has not been adequately laid, with large stones and sub-grade visible in many places leading to surface degradation and trip hazards that will only worsen over time. The surface had not hardened in many areas as should be expected and there were many areas of loose and large size material instead of a smooth finish of hard stone fines. Some loose chippings are inevitable with this surface type as a natural process of scarification takes place, however the large amount of loose material is not acceptable.

Loose surface material is common with subsurface breaking through creating trip hazards

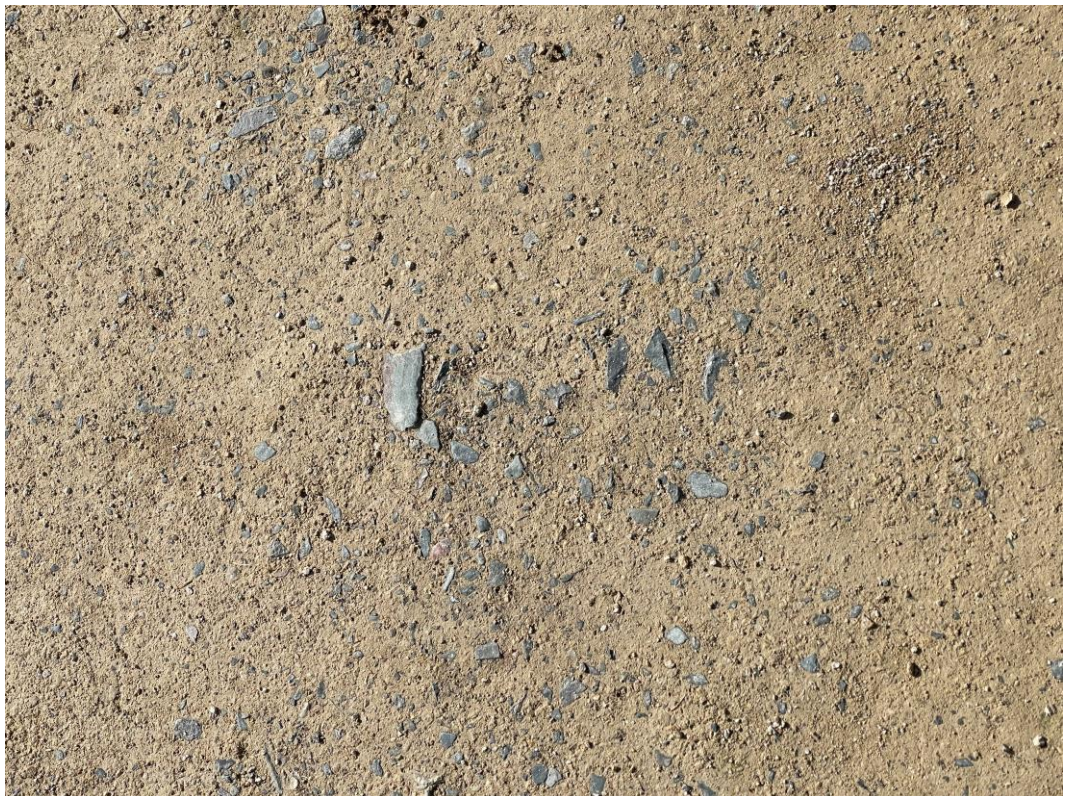
Sub surface breakthrough is common in many areas

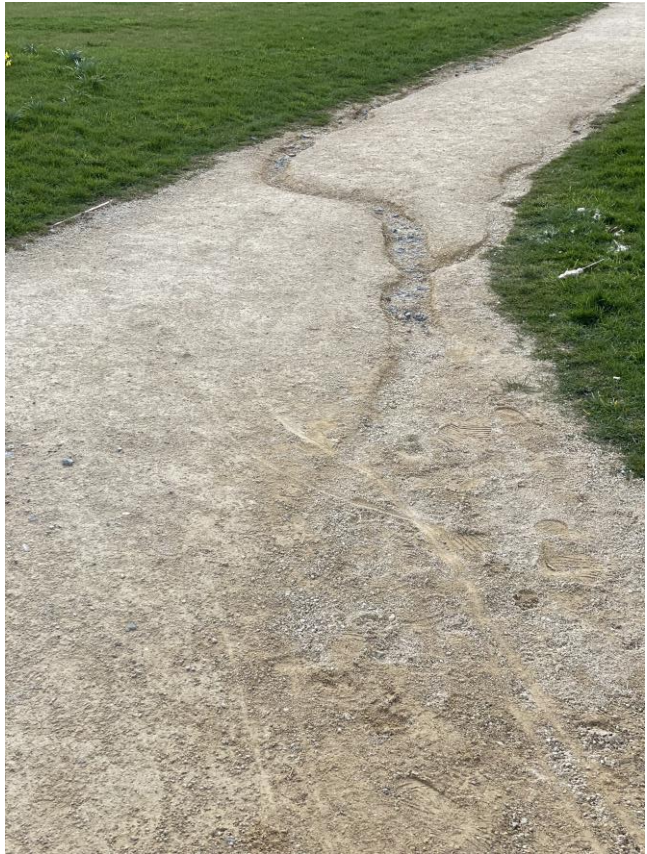
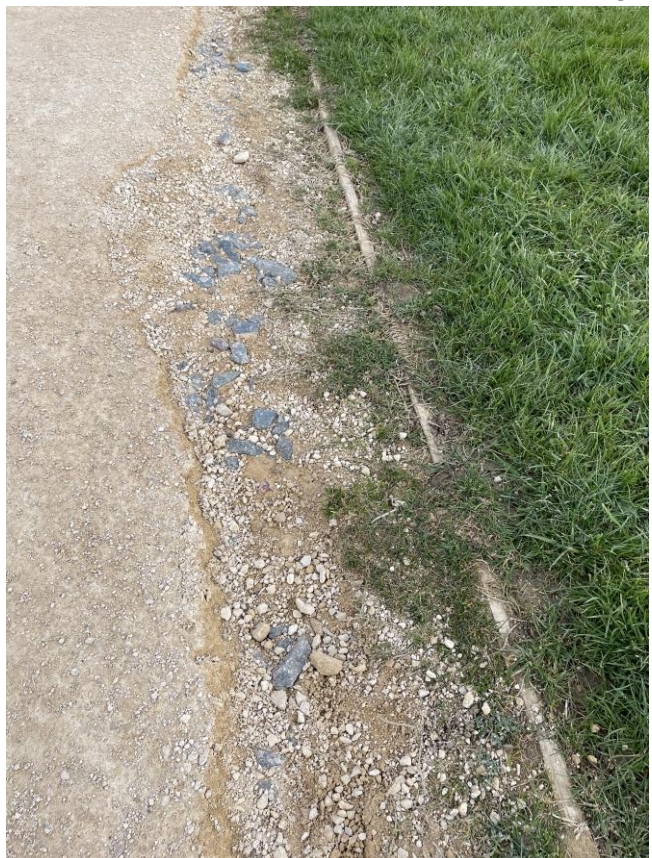
In many areas there appears to be an insignificant or non-existent camber or fall to the footpaths and in wet conditions there are indications that lying water is causing surface damage. In one specific area significant water damage was clear, with large gouges in the footpath surface creating a significant trip hazard. Additional features such as water bars could have been incorporated to prevent this.

Water damage

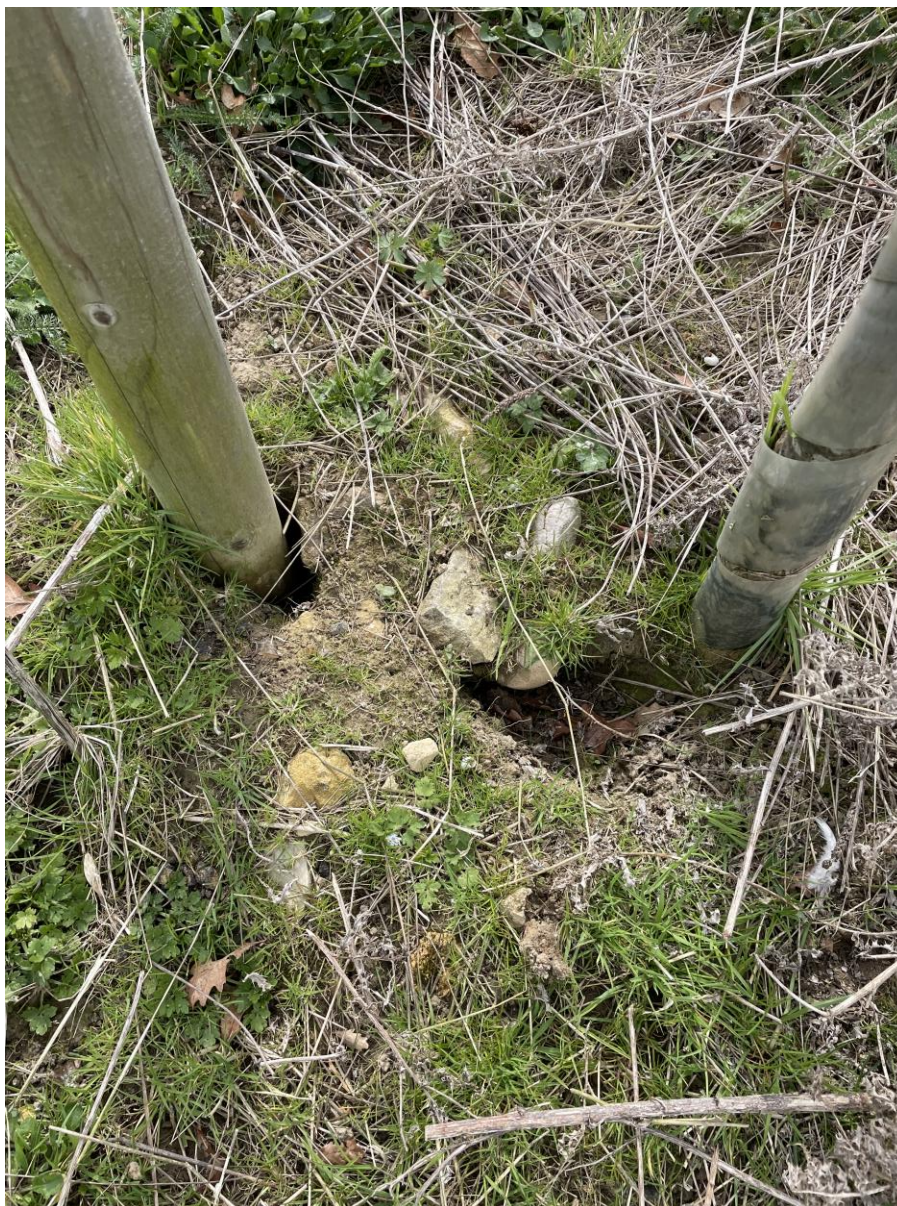
No excavation was carried out to determine soil quality, however there is clear evidence that back fill contained heavy clay soils and large stones.

Dried out ground would indicate heavy clay content, large stones also visible.

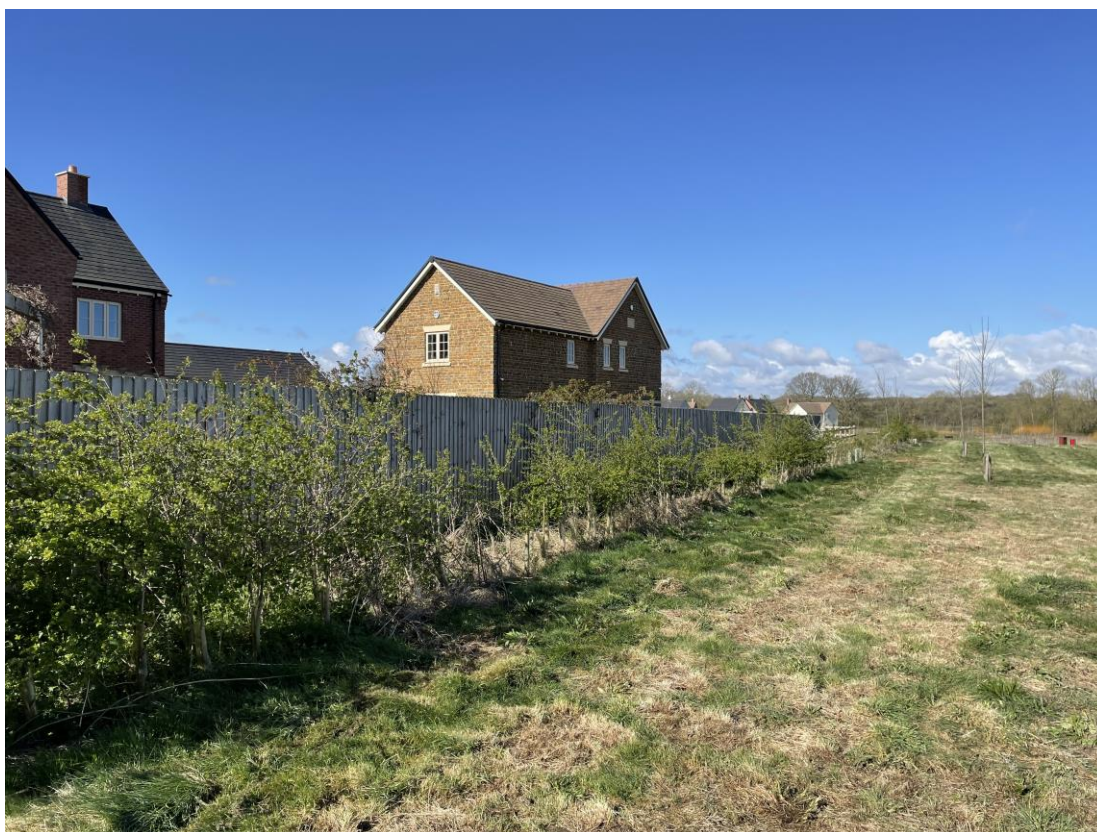
Native hedge to north side of Plot 6

Native hedges were generally planted in single lines rather than double staggered row as per the specification. No double line support as per the specification was provided. However, the native hedges were in generally good order and forming up well. Ongoing maintenance will require the removal of weeds, topping up of bark mulch and filling of any gaps. Plant failures were approximately 5% to 10%, which I do not consider excessive.

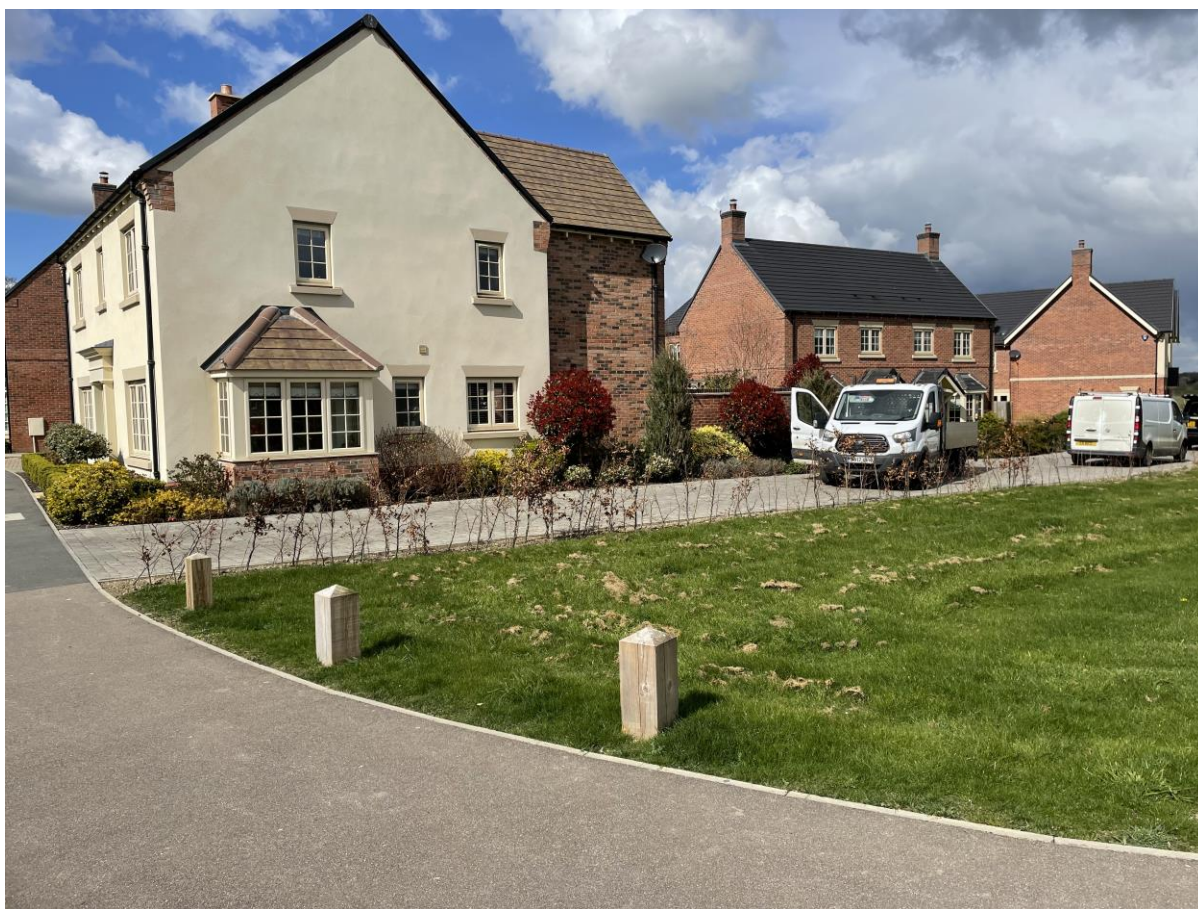
Beech hedge adjacent Plot 12 and running along western edge of POS. Hedge plants undersize and insufficient numbers as opposed to specification. No bark mulch present and heavy clay soil evident. However, with appropriate after care, hedge should thrive in time.

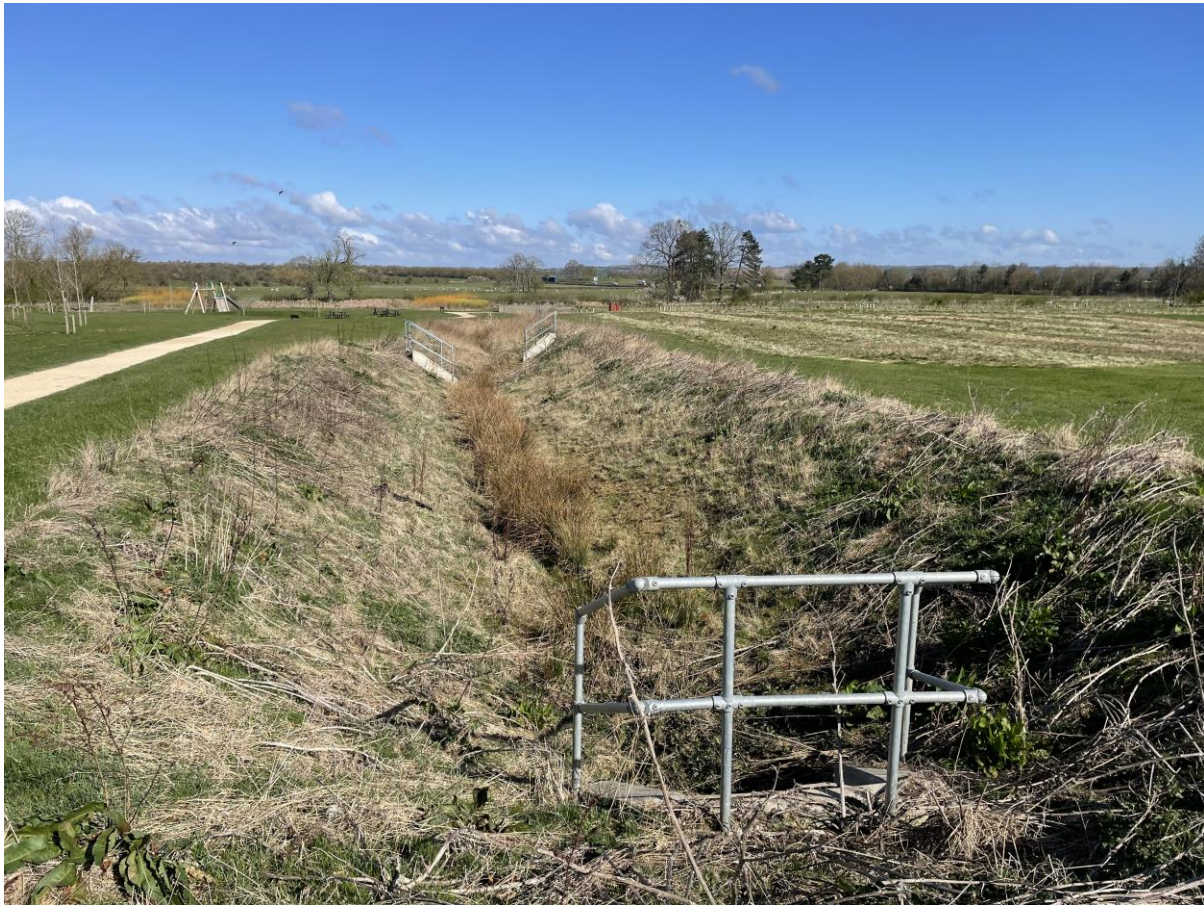
All swale areas appeared to have been sown with a wetland meadow seed mix, however the early season site inspection meant it is difficult to ascertain how successful this has been. Successful establishment will be difficult due to

existing seed bank in soil. Steepness of swale sides in some places should have a required a post and rail fence to prevent access.

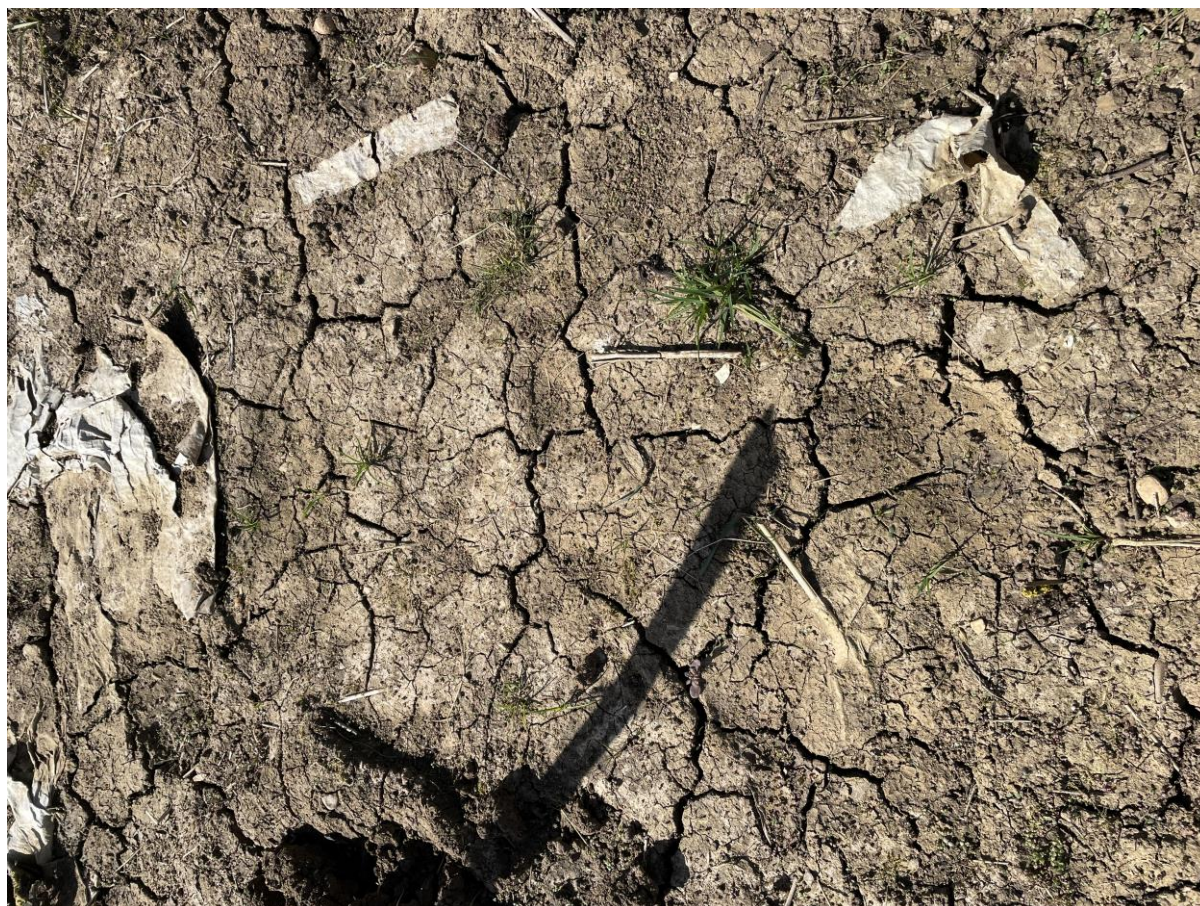
In general the allotment is laid out in accordance with the plans with all facilities provided. One raised planter is damaged and needs repairing. Soils appear poor with significant amounts of heavy clay soils present, with ground rock hard and large cracks appearing. The specification is not clear on quality of topsoil to be provided, only refers to additional topsoil being in accordance with BS3882:2015 where 'additional' topsoil is required. The allotments should be provided with large amounts of organic material soil conditioner to alleviate this situation.

Poor quality heavy clay soils to allotments.
