BULK SAMPLING REPORT

Report Number	Issue Number	Issue Date	
J013652	1	15 Mar 2016	
Site Address		UPRN	
The Symington Building, Adam & Eve Street, Market Harborough Leicestershire, LE16 7AG		N/A	
Scope of Sampling			
Sampling of roofing material			
Client Specific Requirements			
Roof works

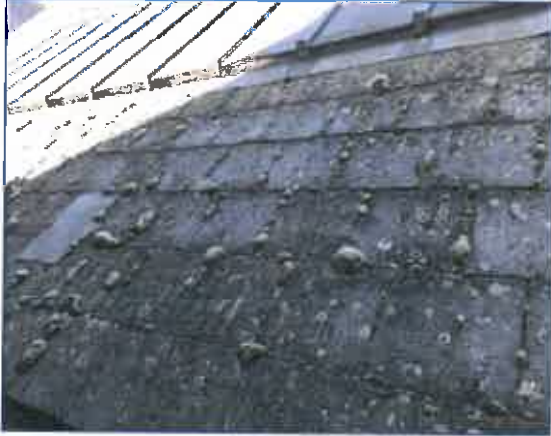
Room Code	Designation/Block	Floor	Ref no.		
E.01	N/A	External	001 - AN003599		
Location	Description	Position	Quantity		
External	Cement roof tiles	Roof	>100m ²		
Material Assessment Algorithm					
A-Product Type	B-Extent of Damage	C-Surface Treatment	D-Asbestos Type	Material Score (A+B+C+D)	Potential to Release Fibres
Asbestos Cement (1)	Good Condition(0)	Surface Sealed(1)	Chrysotile (1)	3	Very Low
Accessibility	Usually inaccessible or unlikely to be disturbed		Action Priority	Longer term	
Photo Ref:	1		Discussion & Recommended Action (in accordance with CAR 2012)

Management Action		
			No action required as material is in good condition. Inspect at regular intervals and consider labelling if not already labelled		
			Additional Comments		
Remove if likely to be disturbed by proposed works					
Who can work with / remove this material	Non-Licensed Materials		Recommended re-inspection in:	12 months

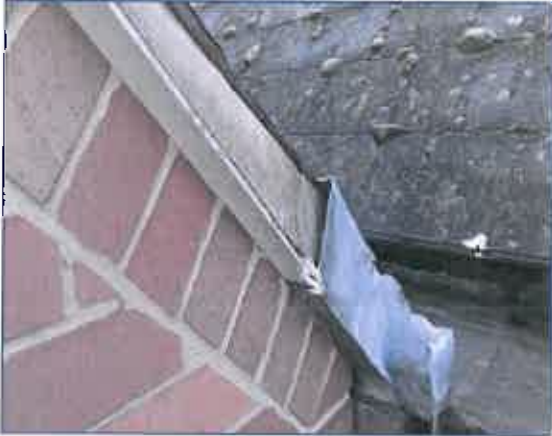
Room Code	Designation/Block	Floor	Ref no.		
E.01	N/A	External	002 - AN003600		
Location	Description	Position	Quantity		
External	Cement undercloaking	Roof	>30lm		
Material Assessment Algorithm					
A-Product Type	B-Extent of Damage	C-Surface Treatment	D-Asbestos Type	Material Score (A+B+C+D)	Potential to Release Fibres
Asbestos Cement (1)	Good Condition(0)	Surface Sealed(1)	Chrysotile (1)	3	Very Low
Accessibility	Usually inaccessible or unlikely to be disturbed		Action Priority	Longer term	
Photo Ref:	2		Discussion & Recommended Action (in accordance with CAR 2012)

Management Action		
			No action required as material is in good condition. Inspect at regular intervals and consider labelling if not already labelled		
			Additional Comments		
Not applicable					
Who can work with / remove this material	Non-Licensed Materials		Recommended re-inspection in:	12 months

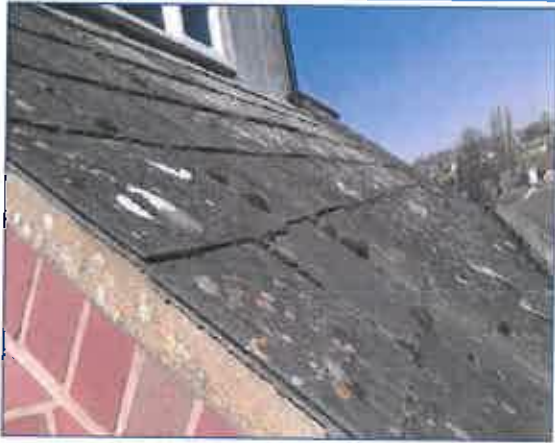
Room Code	Designation/Block	Floor	Ref no.		
E.01	N/A	External	004 - AN003602		
Location	Description	Position	Quantity		
External	Cement roof tiles	Roof	>100m ²		
Material Assessment Algorithm					
A-Product Type	B-Extent of Damage	C-Surface Treatment	D-Asbestos Type	Material Score (A+B+C+D)	Potential to Release Fibres
Asbestos Cement (1)	Good Condition(0)	Surface Sealed(1)	Chrysotile (1)	3	Very Low
Accessibility	Usually inaccessible or unlikely to be disturbed		Action Priority	Longer term	
Photo Ref:	4		Discussion & Recommended Action (in accordance with CAR 2012)

Management Action		
			No action required as material is in good condition. Inspect at regular intervals and consider labelling if not already labelled		
			Additional Comments		
Remove if likely to be disturbed by proposed works					
Who can work with / remove this material	Non-Licensed Materials		Recommended re-inspection in:	12 months

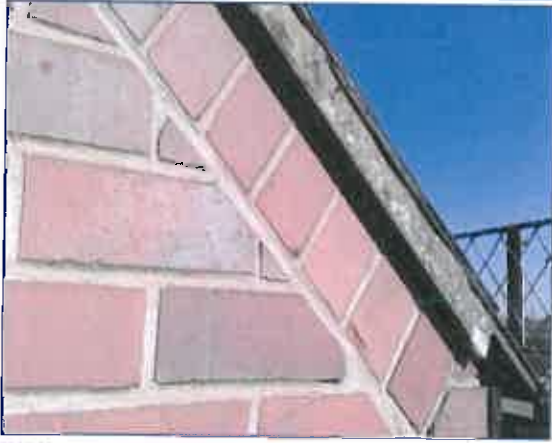
Room Code	Designation/Block	Floor	Ref no.		
E.01	N/A	External	005 - AN003603		
Location	Description	Position	Quantity		
External	Cement undercloaking	Roof	>30lm		
Material Assessment Algorithm					
A-Product Type	B-Extent of Damage	C-Surface Treatment	D-Asbestos Type	Material Score (A+B+C+D)	Potential to Release Fibres
Asbestos Cement (1)	Good Condition(0)	Surface Sealed(1)	Chrysotile (1)	3	Very Low
Accessibility	Usually inaccessible or unlikely to be disturbed		Action Priority	Longer term	
Photo Ref:	5		Discussion & Recommended Action (in accordance with CAR 2012)

Management Action		
			No action required as material is in good condition. Inspect at regular intervals and consider labelling if not already labelled		
			Additional Comments		
Remove if likely to be disturbed by proposed works					
Who can work with / remove this material	Non-Licensed Materials		Recommended re-inspection in:	12 months
